This errata sheet provides information about known device issues affecting Arria® V production devices.

Device Errata for Arria V Production Devices

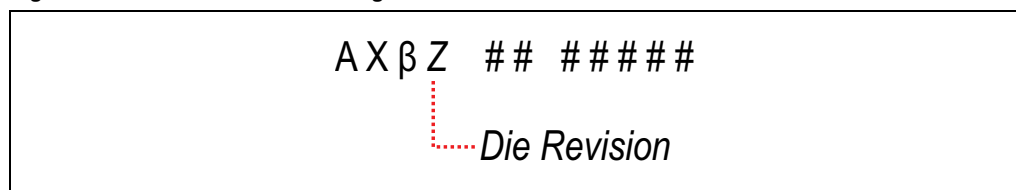
Figure 1. Altera Date Code Marking Format

Figure 1 shows the silicon revision as identified by the 4th letter of the Lot ID.

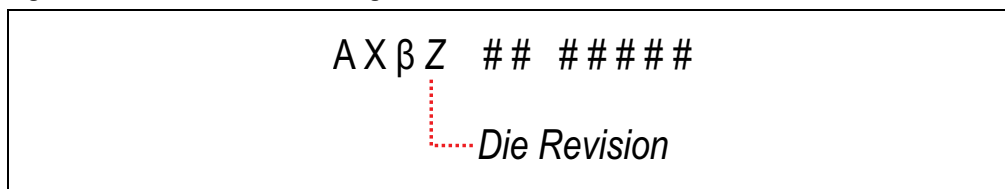
Figure 3. Altera Date Code Marking Format

[Figure 3](#) shows an Arria V device's top side date code.

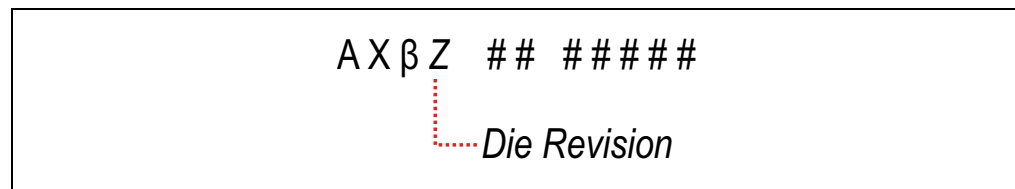
Figure 5. Altera Date Code Marking Format

[Figure 5](#) shows the silicon revision as identified by the 4th letter of the Lot ID.
